# DECAY OF THE RESTORATION RENDER MORTAR OF THE CHURCH OF SAN MANUEL AND SAN BENITO, MADRID, SPAIN: RESULTS FROM OPTICAL AND ELECTRON MICROSCOPY

M.J. Varas<sup>a</sup>, M. Alvarez de Buergo<sup>b</sup>, E. Perez-Monserrat<sup>b</sup>, R. Fort<sup>b</sup>

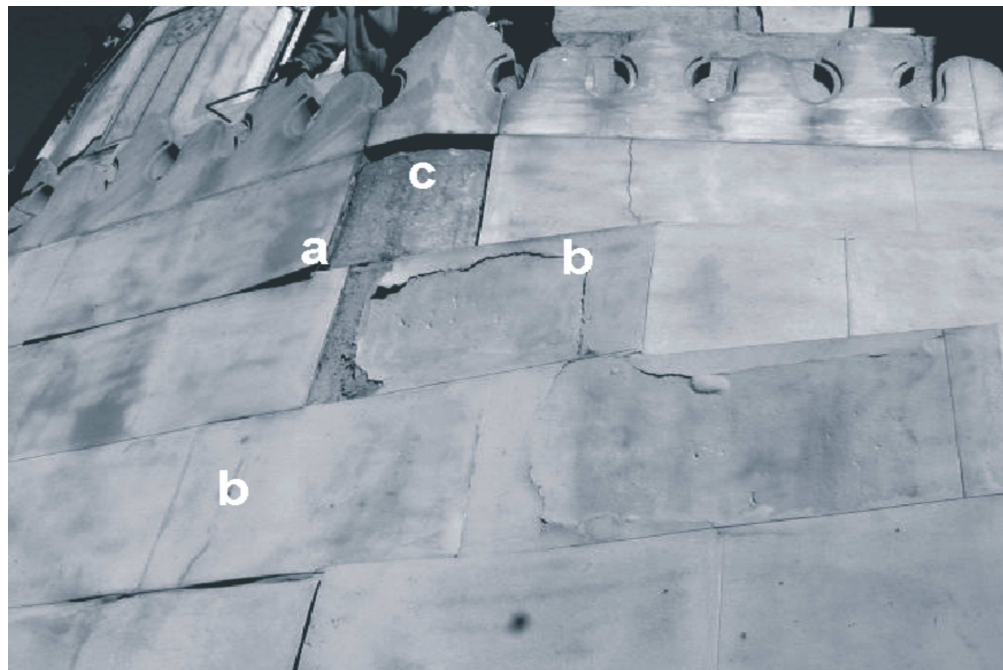
At present, the restoration render mortar is extremely degraded in the drum area, with bulging and fissuring that sometimes lead to the complete detachment of mortar fragments of significant volume (Fig. 3). These breakages are severe in the upper areas oriented W, SW, S and SE (Fig. 2) and are mainly located under the windows level of the drum (Fig. 6) and at the slope change with the roofing of the side chapels (grader area, Fig. 3).

Fig. 3. The fissure pattern (a) in the rendering mortar follows the original stonework joints. The increasing bulging that results on mortar cracks (b) and, later on, on the mortar detachment (c).

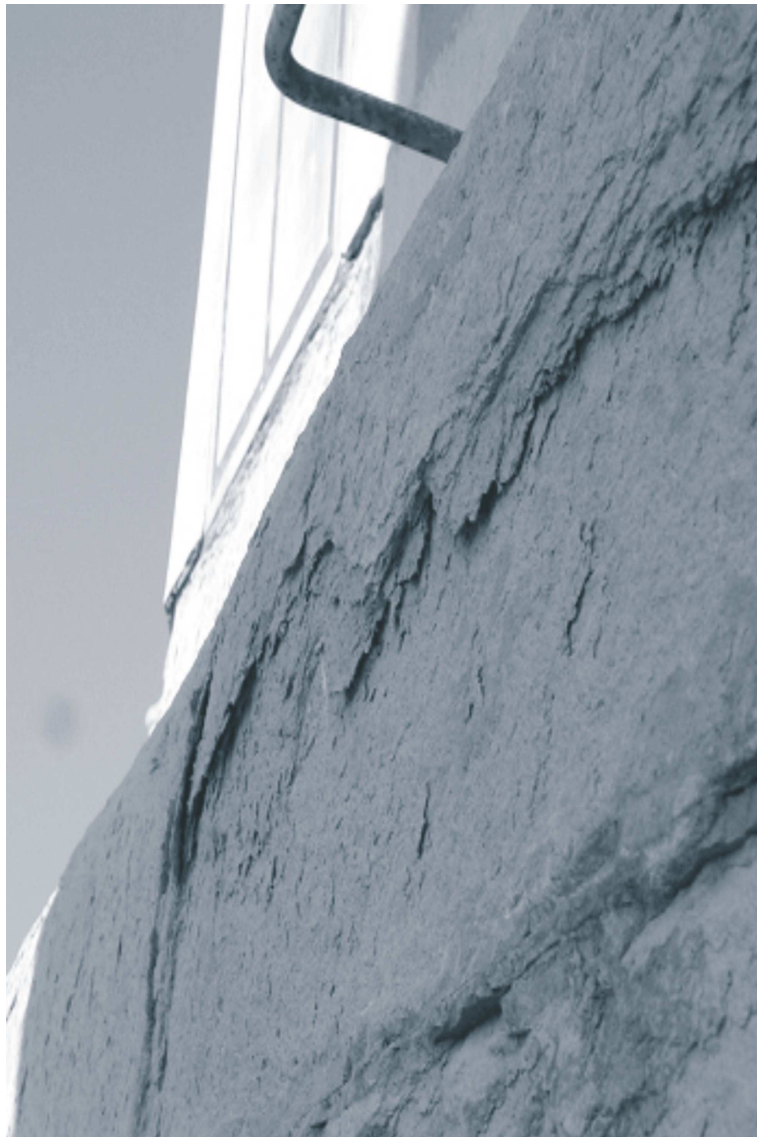
weakened due to intense flaking and spalling, which have led to surface stone fragments becoming detached (Fig. 4). This deterioration process has penetrated to 5-6 cm beneath the stone surface.

Fig. 4. The stone under the rendering mortar is severely and strongly decayed. The most frequent deterioration forms are flaking and spalling, involving a great amount of surface volume loss.

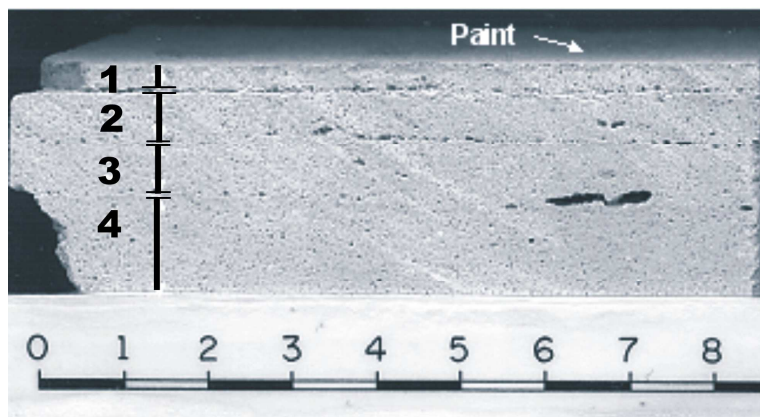
Fig. 5. Multilayered mortar applied on the surface of the decayed stone. The interface among the different layers is characterized by the presence of a high number of air voids.

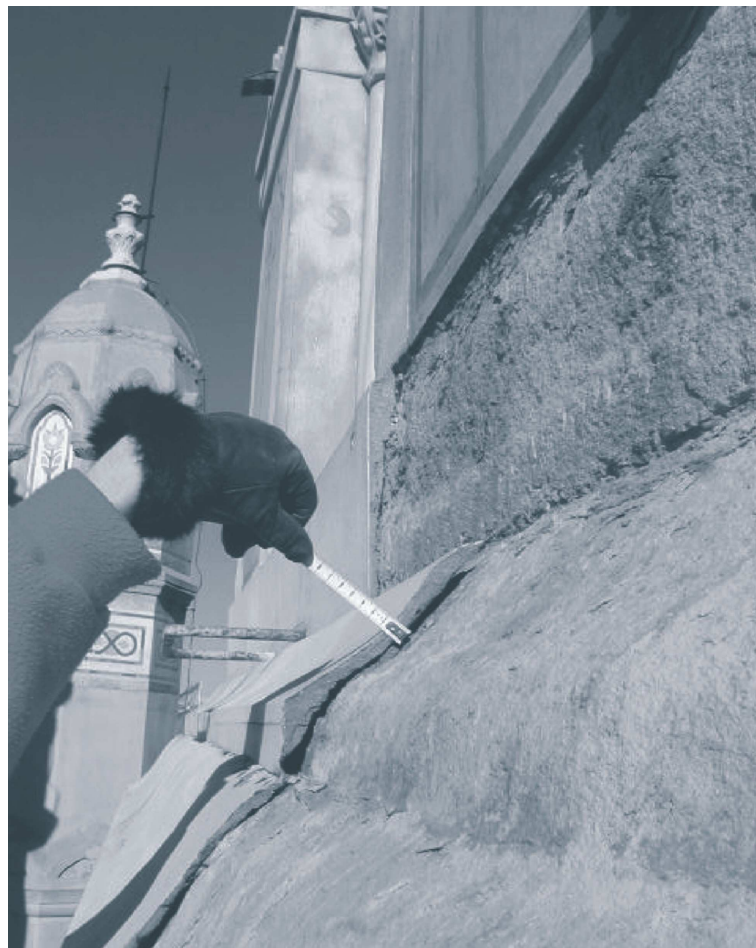
Fig. 6. The mortar applied on the surface of the decayed stone has been used to reproduce many architectural and ornamental elements that were lost.

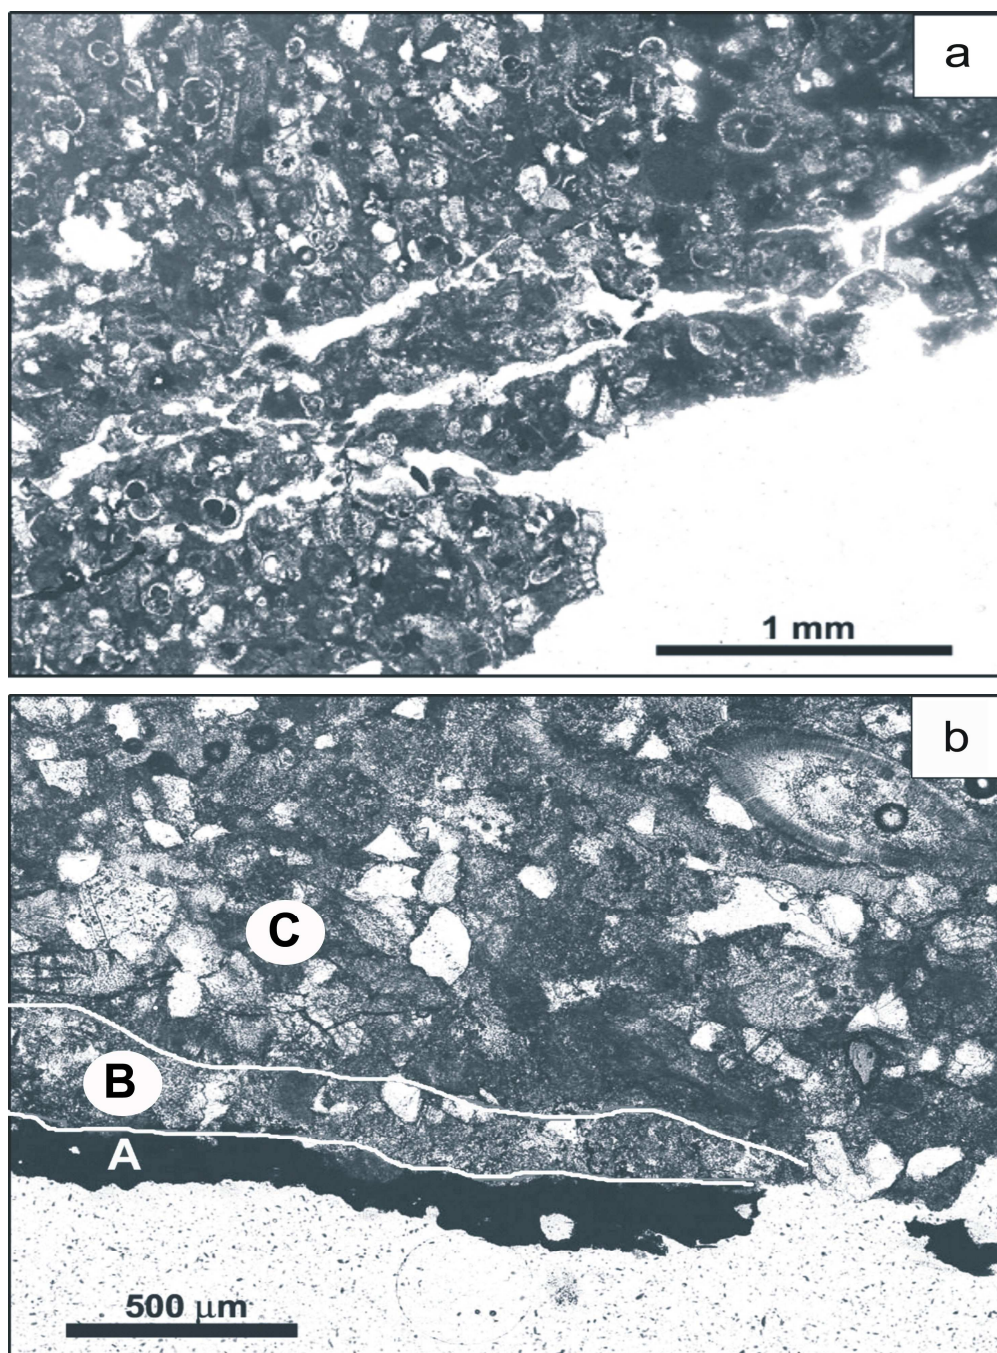
Macroscopically visible flaking continues at microscopic scale, leading to delamination and increased permeability (Fig. 7a). Fissure width varies from 0.37 mm at depth, to 0.9 mm near the surface. This fissuring process affects all the stone constituents (bioclasts, matrix and cement).

The stone is not always covered by the mortar rendering but by a yellowish paint. It is a homogeneous, compact, dark-coloured layer that covers the irregularities of the stone surface and has a thickness ranging from 0.1 to 0.15 mm (Fig. 7b).

Fig. 7. Micrographs under OM (plane polarized light, PPL) of the stone. a) The presence of fissures parallel to the external surface is the responsible for the flaking of the stone surface. c) Weakness area (B; high porosity) under the paint layer (A) that may occur directly on the stone (C).

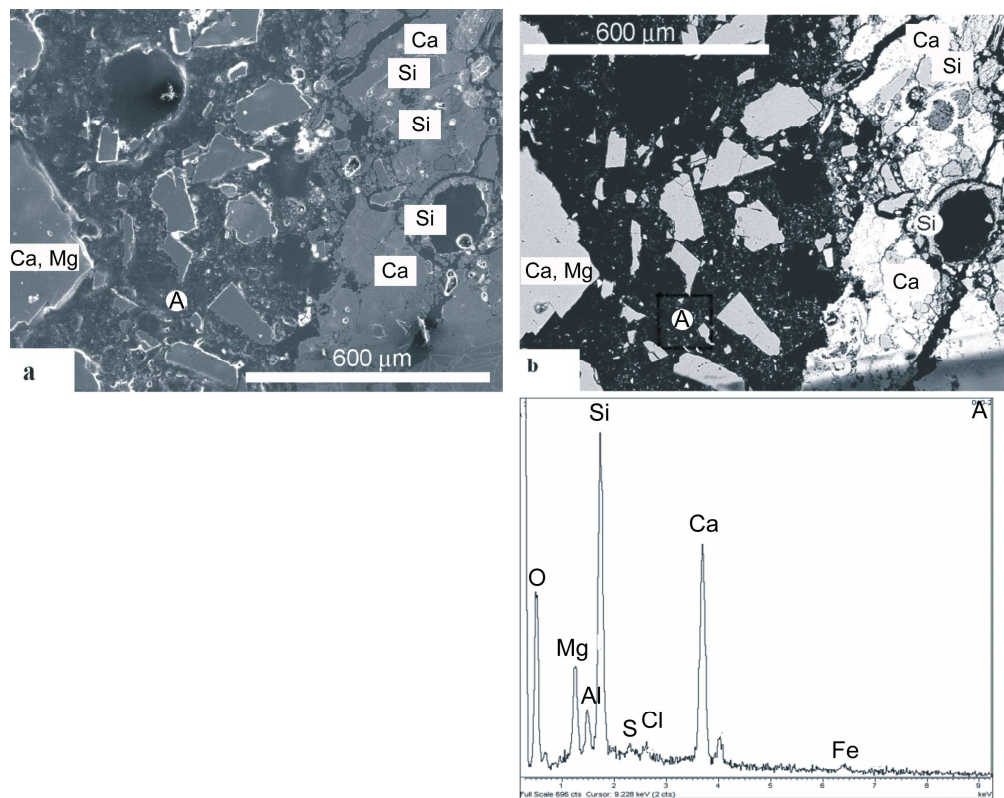
The SEM-EDS study of this calcareous substratum confirms what was observed under the OM. The chemical composition detected is mainly Ca, followed by Si. SEM also made it possible to detect the micro-fissures on the stone surface (Fig. 8). The paint layer, which covers the stone, appears as a poorly consolidated layer with significant porosity in its interior and in contact with the underlying stony

Fig. 8. SEM micrographs (secondary electrons mode) (a) and backscattered mode (b) of a polished section of the contact between the highly fissured limestone (right) and the rendering mortar (left). The stone contains Ca and Si. The mortar is constituted by a dolomitic aggregate (Ca and Mg) and a binder (A –point analysis) composed of gypsum (Ca and S), prime coat (Si, Al and Mg) and colouring pigments (Fe).

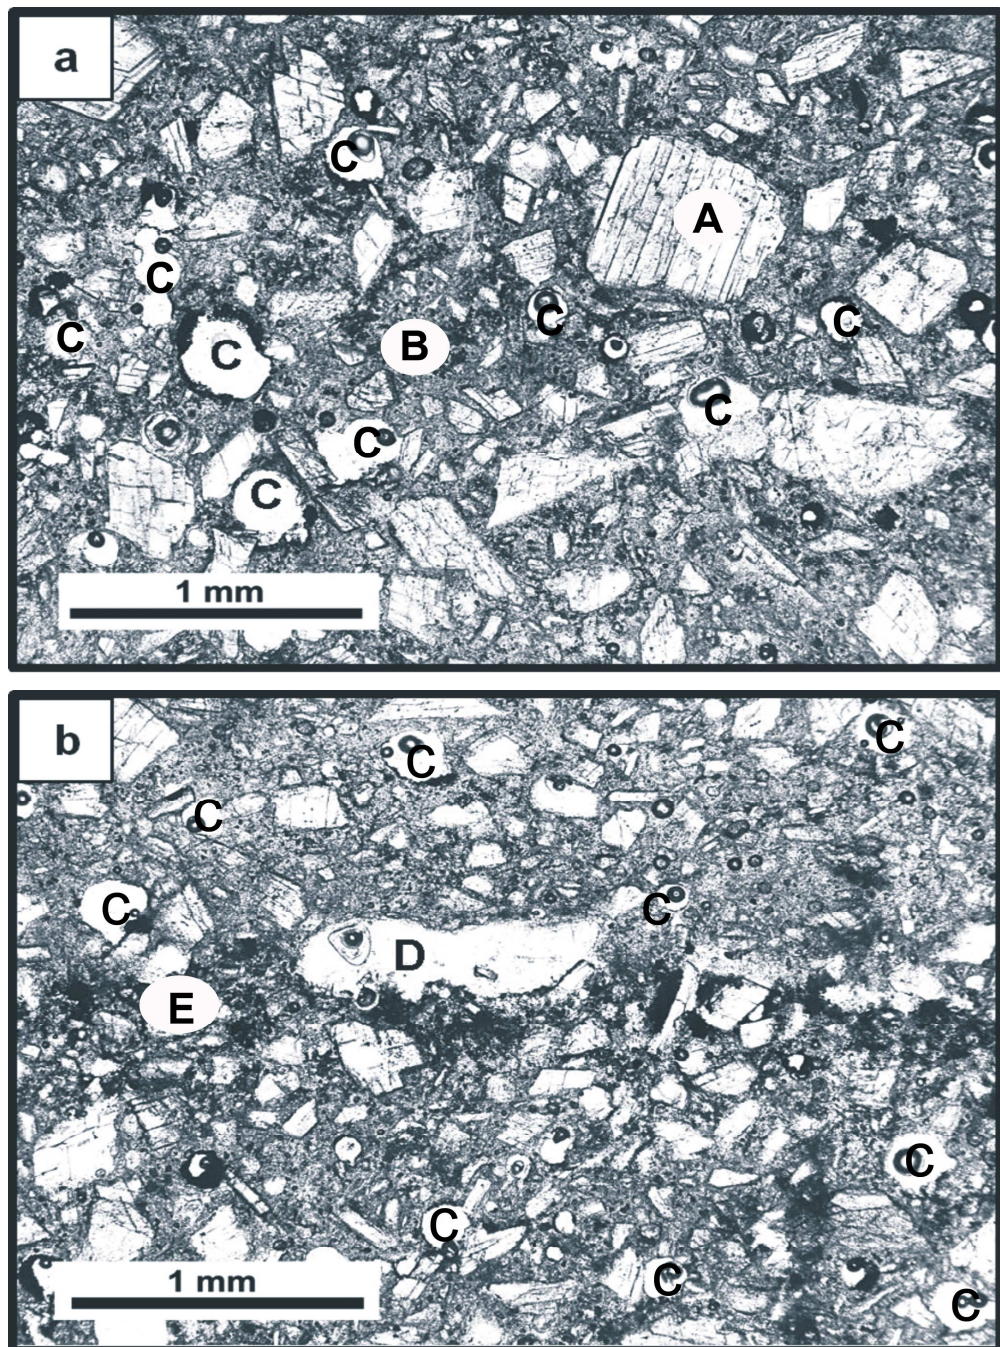
With the OM it is possible to recognise dolomitic marble aggregates floating within a micro-crystalline mass with a massive aspect and undefined mineralogy. These aggregates are very angular and have a well-defined grain-sized selection consisting of three dominant types: 0.1, 0.3 and 1 mm. The morphology of the air voids is very regular and circular. The voids are located within the micro-crystalline matrix (Fig. 9a). Porosity measured by MIP is 22.2%.

As mentioned earlier, the rendering may have a single layer, although multi-layer rendering is more frequent. In the latter case (Fig. 9b), the successive layers which appear are very similar to each other but differ slightly in colouring and thickness, as well as in the amount and morphology of the voids. The more superficial layers are thinner and more compact. The aggregate is in contact and its main axis, together with the axis of the voids, is oriented parallel to the surface of the mortar. The lower, thicker layers are not as compact as the upper layers; therefore, the aggregate is very loose and does not appear in contact with each other. No type of orientation of the main axis can be observed.

Fig. 9. Micrographs under OM (plane polarized light, PPL) of the rendering mortar.  
 a) General appearance of the mortar (A-dolomitic aggregate, B-binder, C-air voids).  
 b) The different layers of the mortar are limited by the presence of elongated voids (D) and by a dark layer (E).

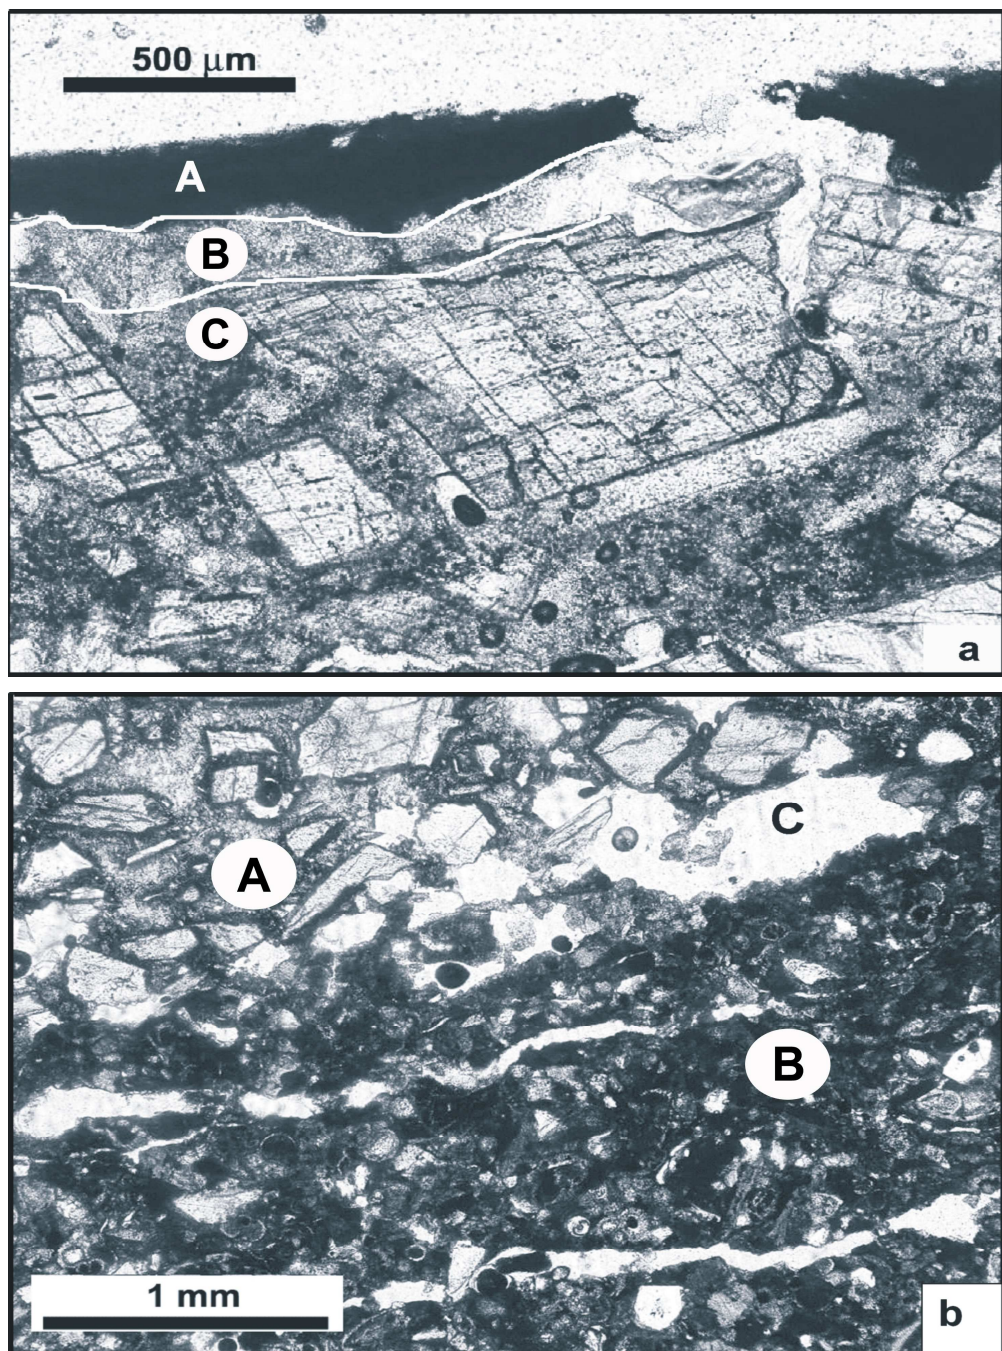
A thin film of yellow paint always appears on this mortar, giving the surface a uniform appearance (Fig. 10a). In thin section, the yellow topcoat appears as dark colored layer 150-500  $\mu\text{m}$  thick, covering the irregular mortar surface. Bonding of the topcoat is incomplete, as demonstrated by a bead-chain of air voids on the interface with the substratum. Also, there is a much more substantial porosity which separates the layer of paint on the underlying rendering mortar and is particularly higher in the superficial part of this mortar.

The rendering mortar adheres directly to the stone, which has a high degree of deterioration with superficial cracking (Fig 10b). Voids with lengthened morphology, made up of the coalescence of previous underlying rounded voids, are observed. Fundamentally, these voids appear at the base of the rendering in contact with the stone. Cracking, horizontal and parallel with the surface of the stone, affects the base of the rendering.

Fig. 10. Micrographs under OM (plane polarized light, PPL) of: a) The paint layer (A) that is also on the modern rendering mortar (C). There is a weakness area in the interface between the paint layer and the most external section of the mortar (B; high porosity). b) The contact area between the strongly fissured natural stone (B) and the rendering mortar (A). There are elongated voids along this contact plane (C).

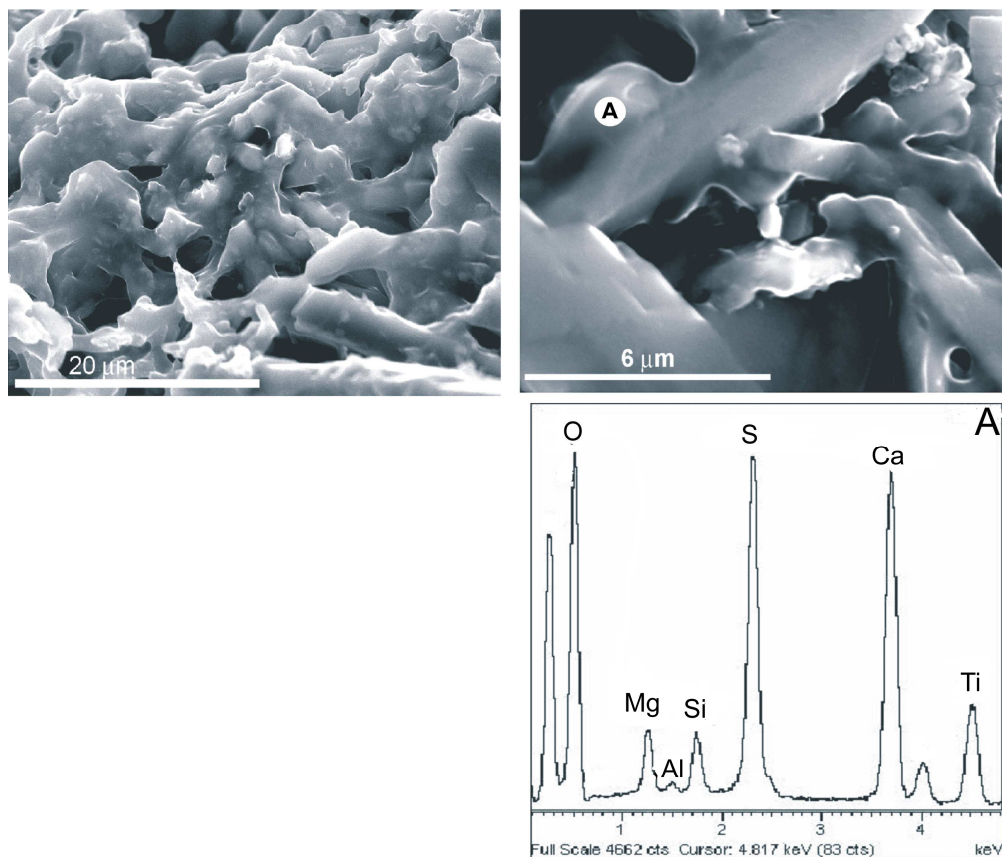
Fig. 11. SEM micrographs (secondary electrons mode) and EDS spectrum of a fragment of the rendering mortar. The gypsum crystals present growing enlargement due to the impregnation with prime coats (Si, Al and Mg) and to the pigments (Ti and Fe) added to the binder. Point analysis (A).

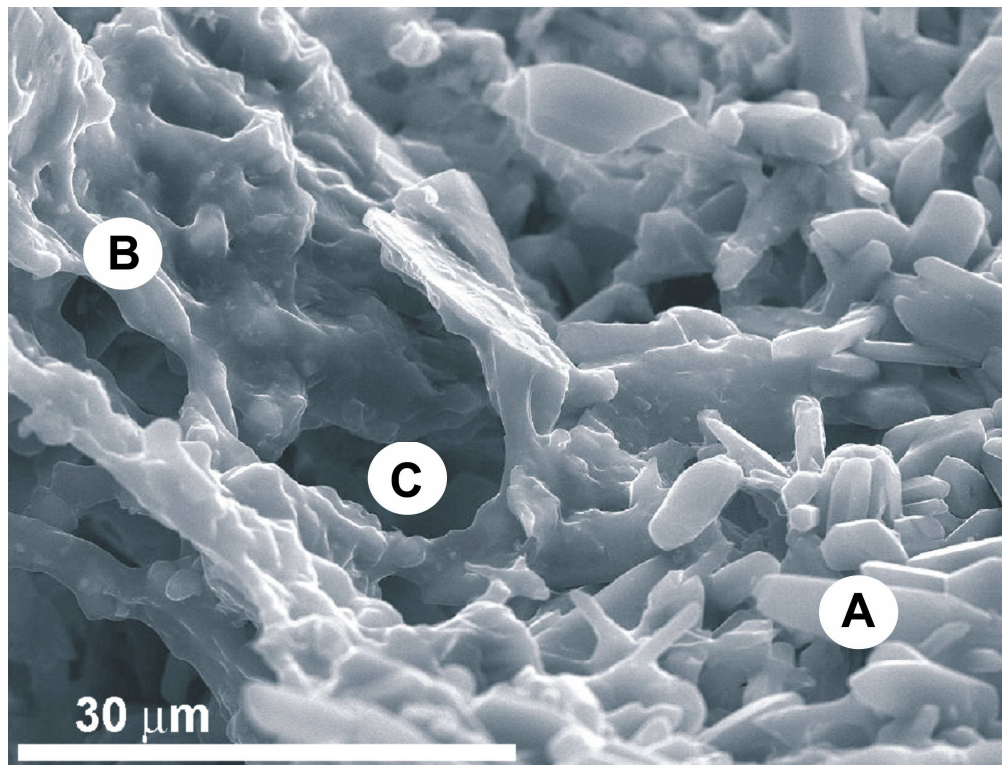
appear in the contact zone of the layers of mortar. When there are two layers, these chemical composites (mainly containing Si, Al and Mg) impregnate the surface of the lower layer and especially affect all the binder (Fig. 12). In this area of contact between layers, the line of lengthened voids previously detected with the OM again appears and affects the base of the layer which is applied last (Fig. 12). These impregnations correspond to the extended dark stains which appear in the OM and which make it possible to differentiate the layers of mortar (Fig. 9).

Fig. 12. SEM micrographs (secondary electrons mode) of a fragment of the rendering mortar. A-Gypsum crystals without prime impregnation (mortar, upper layer), B-Gypsum crystals with prime impregnation (mortar, lower layer) and C-Air voids in between both layers.

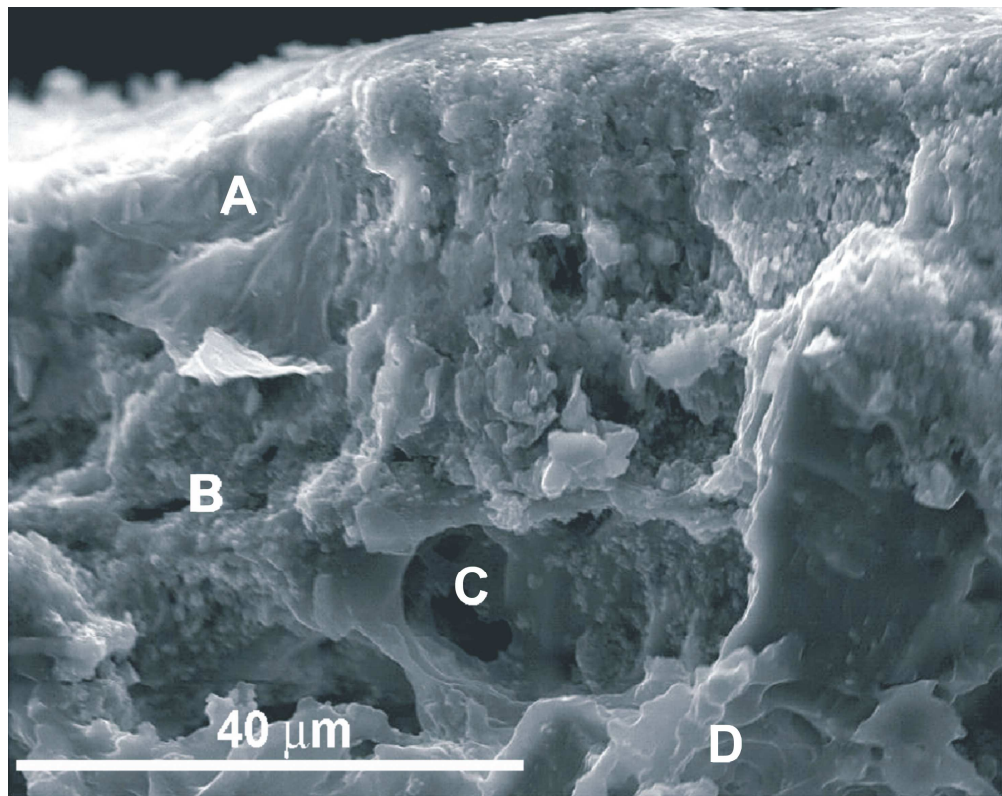
The layer of paint which covers the surface of the rendering mortar was studied in greater detail through the SEM+EDS. This layer has a variable thickness (50-100  $\mu\text{m}$ ), a granulated appearance and a Ti dominant chemical composition, containing also Fe, Si, Al and Ca traces. A thin film (20-30  $\mu\text{m}$ ) containing Si, Al and Mg covers its surface. The lower interface of the paint layer is quite irregular as it adapts to the irregularities of the surface of the mortar. Substantial porosity was detected in the paint mortar contact area (Fig. 13).

Fig. 13. SEM micrographs (secondary electrons mode) of a fragment of paint, surface layer. A-Film corresponding to a water-repellent treatment, B-Paint layer, C-Voids and D-Rendering mortar.
